# **SELECTED MUSLIM HISTORIC MONUMENTS AND SITES IN BULGARIA**

**United States Commission for  
the Preservation of America's Heritage Abroad**

**2010**

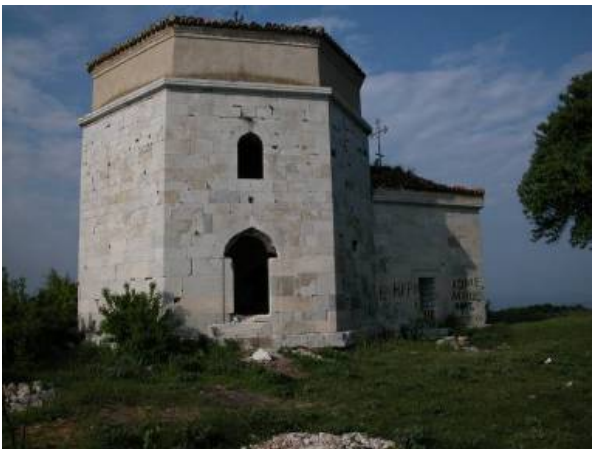
The condition of the *türbe* is quite sound. There are some traces of dampness on the interior walls. As mentioned above, the sarcophagus and grave of the saint were broken open and gutted. The interior walls have recently been painted green and white. On the exterior, a number of marble blocks are broken or have been removed. On the southern side of the exterior, the marble facing is clean; on the northern side it is covered with lichen. On both sides, vegetation appears to be sprouting between the blocks in a number of places. The entranceway to the portico has been defaced with spray-paint graffiti. The *meydanevi*, however, is a complete ruin. Large sections of its eastern-most walls (i.e. those hanging over the precipice) remain standing.

**Lateral view of southern side of monument from the summit on which it is set. Note the fine quality and precision workmanship of the marble facing. Some cracks and missing pieces are evident but, otherwise, the exterior walls have survived the centuries well. The tambour atop the marble walls is made of rubble coated with plaster, a technique that helps us date the monument to the 15<sup>th</sup> century. The tambour was renewed during the restoration of the monument during the late 1960s.**

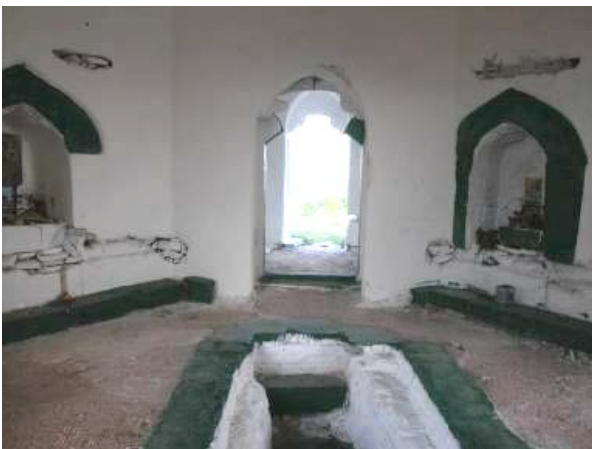
**View from the head of the grave through the vestibule to the interior. The niches to the left and right of the entrance now house makeshift, seemingly Christian shrines.**

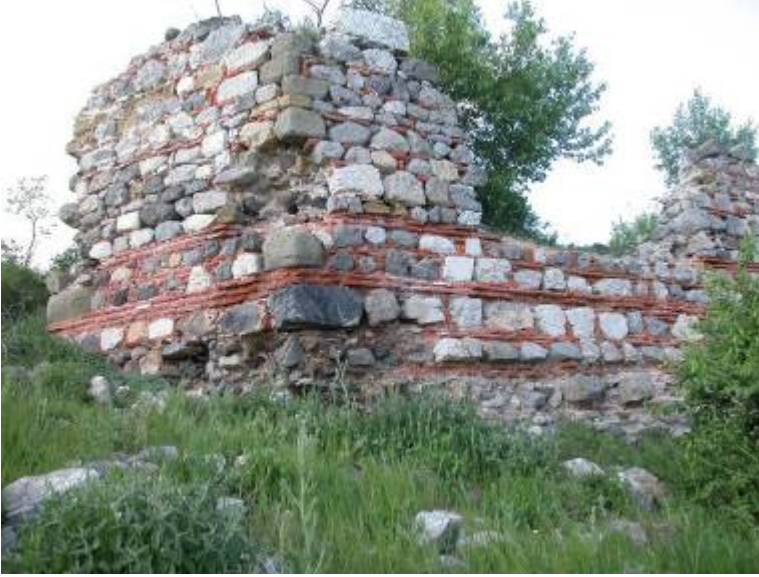
**The *meydanevi* is built at the end of a precipice.**

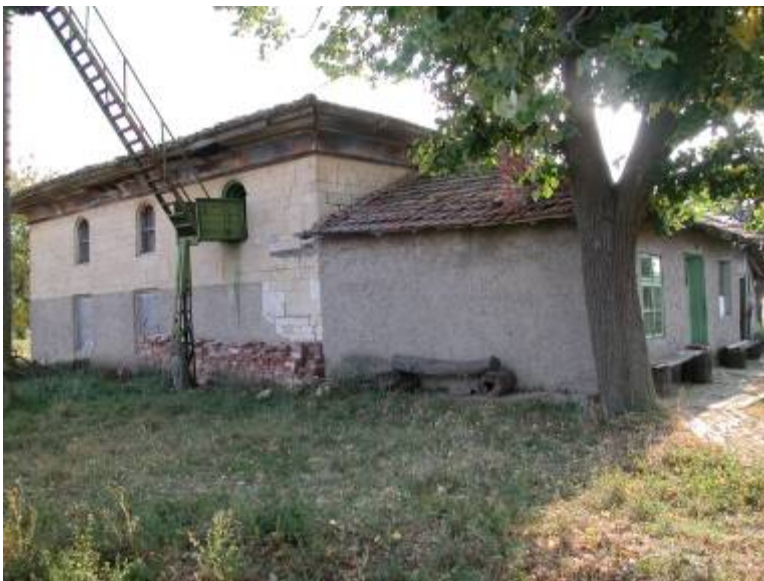
Examination of the exterior shows severe buckling of the walls, possibly due to a poor foundation and shifting soil, a common problem in northeast Bulgaria. Walls need to be reinforced, the gutters should be replaced, the roofing redone, and the foundation may need stabilization.

**Oblique view from left. Note bricked-in portico, improvised access to minaret, cracks and buckling at left front corner, and laying of brick in an attempt to shore up wall.**

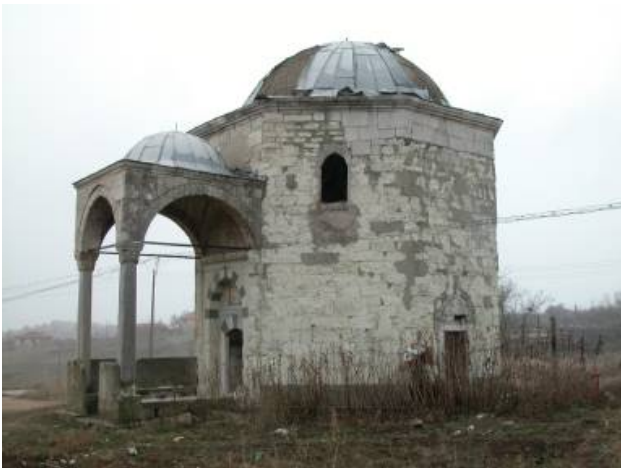
The interior has been gutted and there is some fairly advanced exfoliation of the stone exterior. Also there is no tin roofing (original roofing material would have been lead) over the dome with a 20<sup>th</sup>-century concrete cover. Otherwise, the structure itself appears sound. Still, the roof and the interior and exterior walls require conservation. This monument has exceptional aesthetic value but it is in need of a complete restoration including removal of the unsightly concrete elements emplaced to stabilize the portico.

**Lateral view. Note alternate placement of upper and lower windows.**

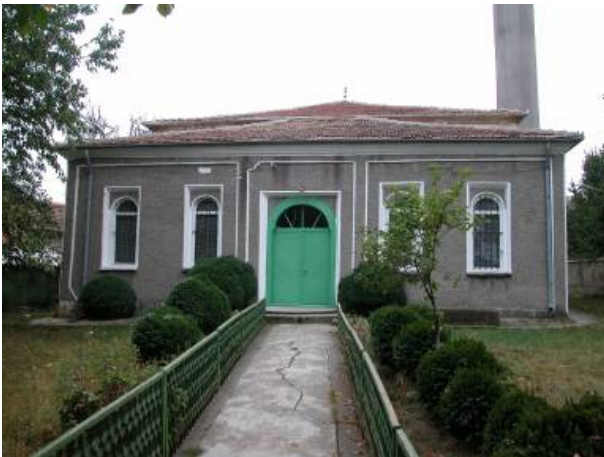
The overall condition of the building is quite good. There is some evidence of dampness on the interior and exterior of the walls as well as some shifted stones possibly due to past earthquakes.

**Entrance through walled-in portico.**

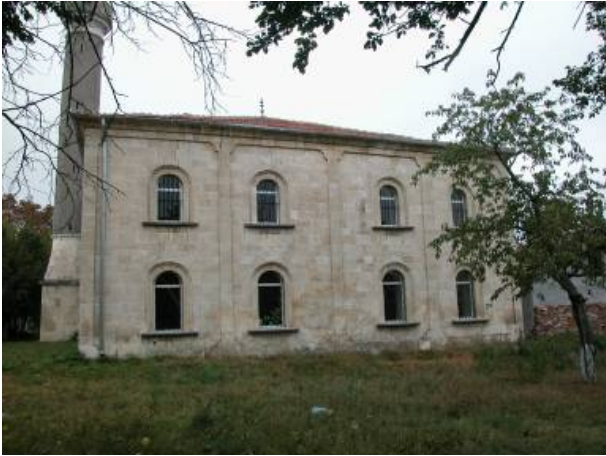
Rear of mosque. Note faux columns and capitals.

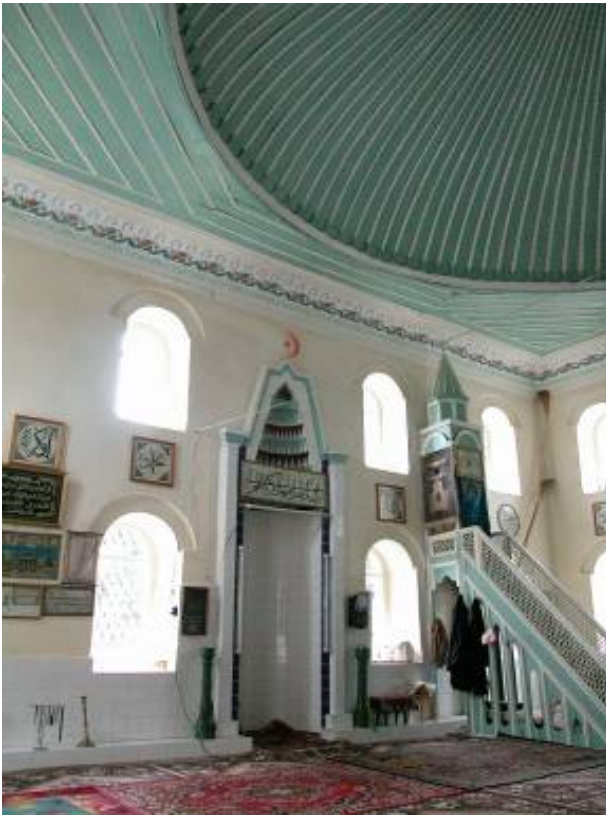
Mihrab and minbar. Note wooden roof and dome.

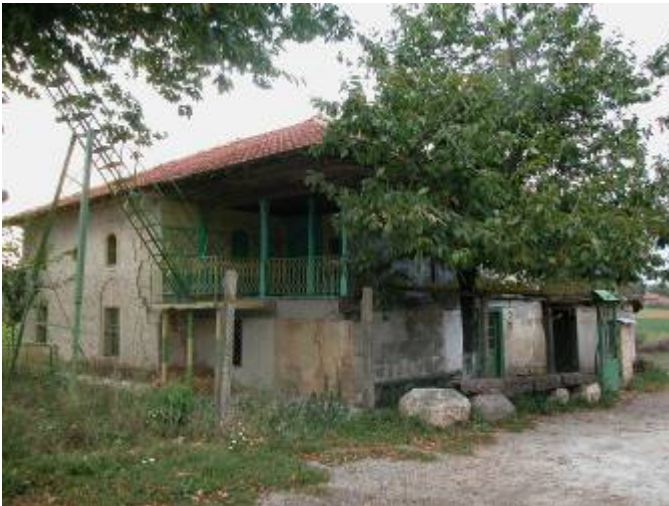
At first glance, the mosque appears to be in decent, albeit shabby, condition. A closer inspection of the walls reveals serious shifting of the stone blocks out of alignment. A very strong smell of dampness is present inside the mosque.

**Exterior. Note shifting of stone blocks near the front of the left lateral wall of the sanctuary. Also note the inclined fireman's ladder-like stairway to the minaret. Minarets of many urban and rural mosques in Bulgaria were ordered torn down or were forcibly razed during two decades of officially directed and often popularly supported anti-Turkish and anti-Muslim campaigns during the 1970s and 1980s.**

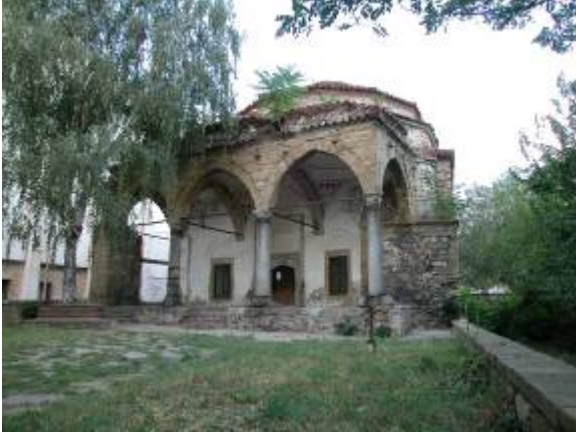
The mosque appears to be in good condition. Superficial examination indicates no need for major work.

**Mosque seen from the terrace.**

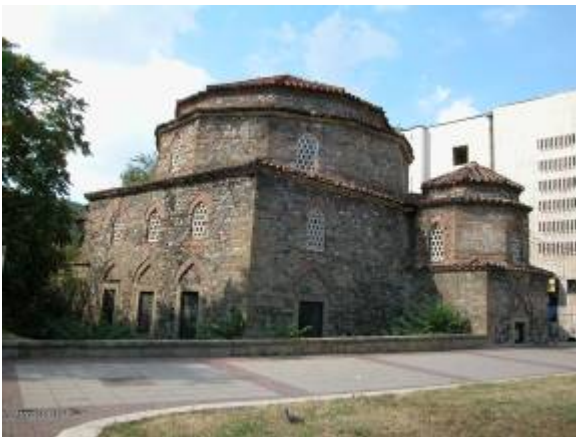
**Rear of mosque from main city square. Note semi-attached *türbe* of founder on the right.**

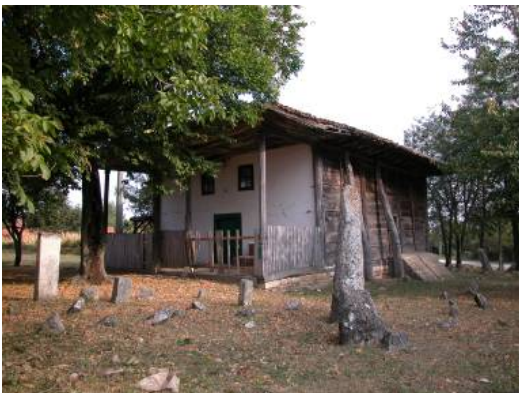
The interior walls show evidence of dampness. The brickwork at the foundation and the newly poured concrete buttresses suggest past and potential future instability of the walls, possibly due to shifting soil, which is a problem endemic to the region.

**Oblique view to front of mosque from right.  
Remains of cemetery in foreground.**

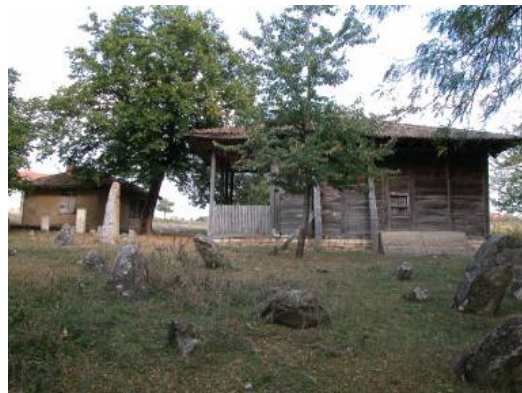
**Lateral view, right side. In the foreground,  
the remains of the cemetery. At the far left,  
the former *mehtep*. Note the older wooden  
buttressing of the wall of mosque and more  
recent brick and concrete reinforcement at  
the base of the wall.**

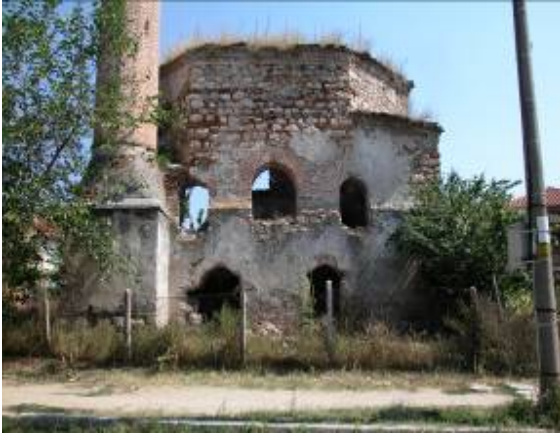
Lateral view with *minaret*.

The structure was designed as a characteristic Ottoman cube surmounted with a dome via transitional elements. It's characterized by robust but unrefined cloisonné work of the walls incorporating both uncut and partially dressed stone. The transition of dome to cube is accomplished through large triangular curved pendentives typical of the second half of the 15<sup>th</sup> century. Also, the transitional drum is unusually high. Its dimensions are 10.5 by 10.5 meters, with a height of at least 10.5 meters.

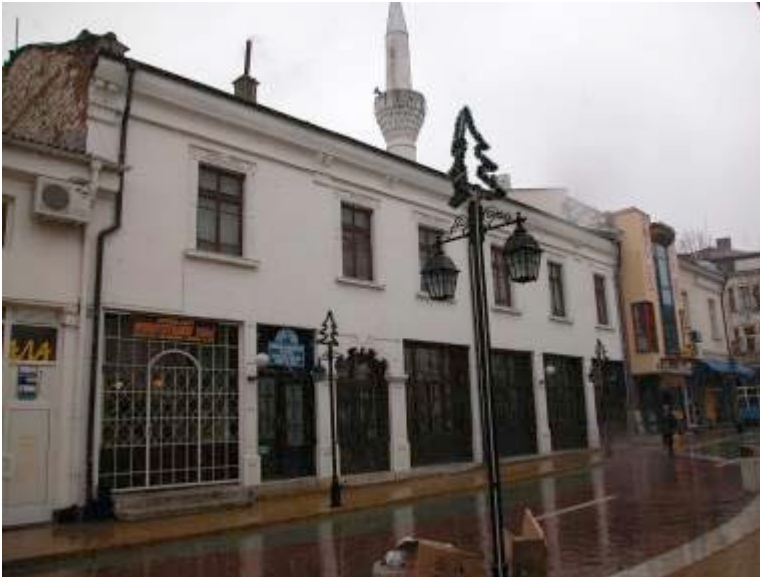
**Entranceway to the mosque is through a portal (center, above) set in a 19<sup>th</sup> century commercial building. The entrance to the offices of the local Mufti is through the doorway to the left of the portal surmounted by a blue sign.**

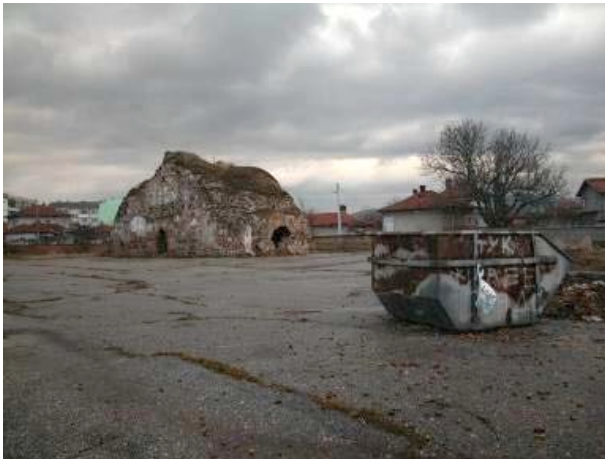
The monument is in terrible condition. It has been in an accelerated rate of decline in recent years, mostly in terms of the enlargement of wall openings and ongoing disintegration of the barrel-vault. For the moment, the façade appears sound despite signs of subsidence.

**The Imaret Camii at Ikhtiman stands in the midst of a large paved lot. The houses at the right rear of the photo are part of the Roma quarter of Ikhtiman.**

In the short run, priorities include cleaning its interior and immediate surroundings, and that the monument be fenced in and covered to protect it from rain and snowfall, and the intentional and accidental depredations of trespassers. Cleaning away shrubs and grass would ensure that roots cause no additional damage to the brickwork.

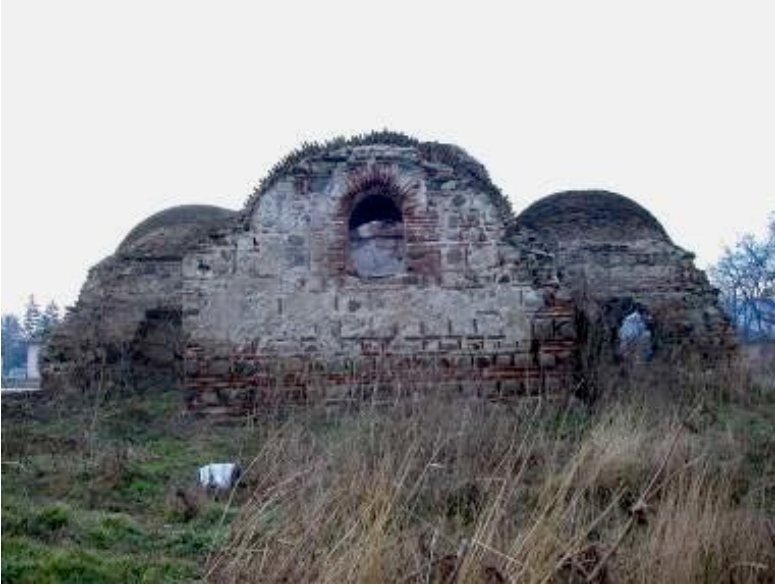
**Rear view. At the center: the rear or *mihrab* wall of the mosque sanctuary. Note that its window opening is original. At the right: The left-hand chamber. Note large holes knocked through the walls of the chamber.**

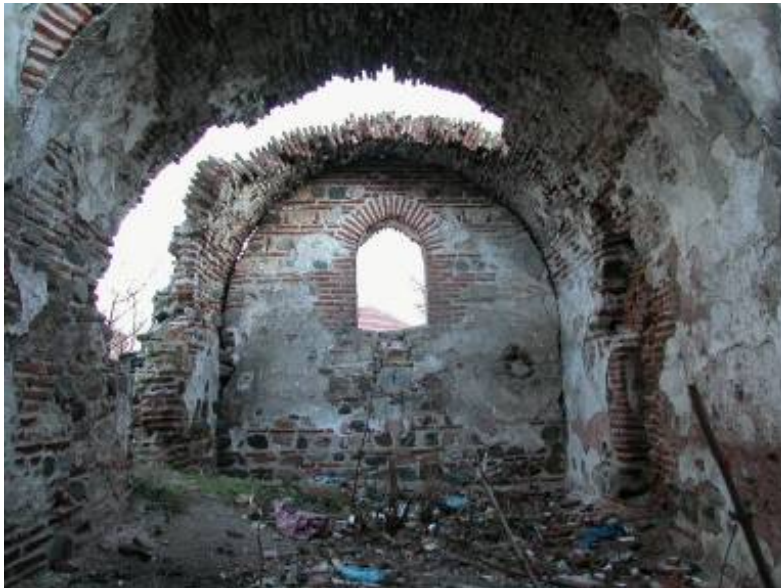
**Interior. The sanctuary. Note the partially collapsed state of the barrel-vault and the buckling of what remains of the left-hand side of the vault at its juncture with the *mihrab* wall.**

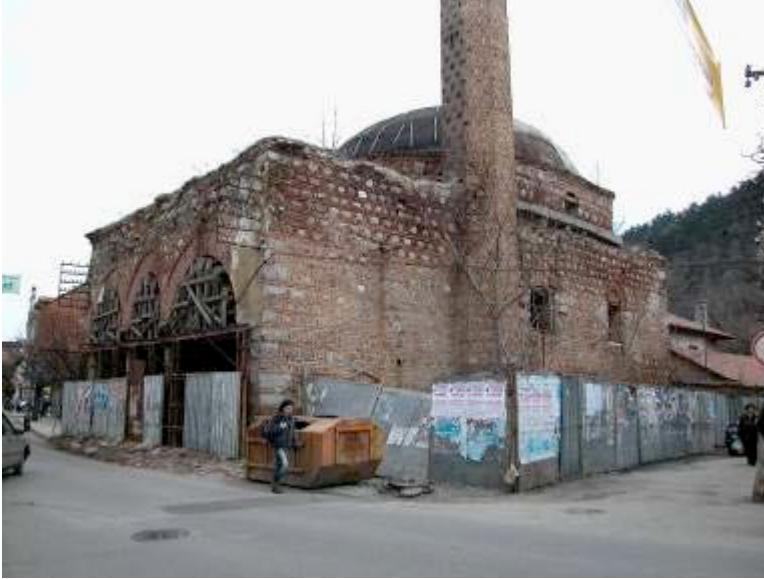
The monument is in very poor condition. Uneven subsidence and vibrations of passing traffic have led to unstable walls that in turn have compromised the integrity of the dome. The masonry is deteriorating and crumbling. The building would need a major restoration, including a possible injection of concrete foundation under the building and the creation of a lightweight concrete shell to support the dome.

**Oblique view from right. Mosque fronts on the main traffic thoroughfare running through Kyustendil.**

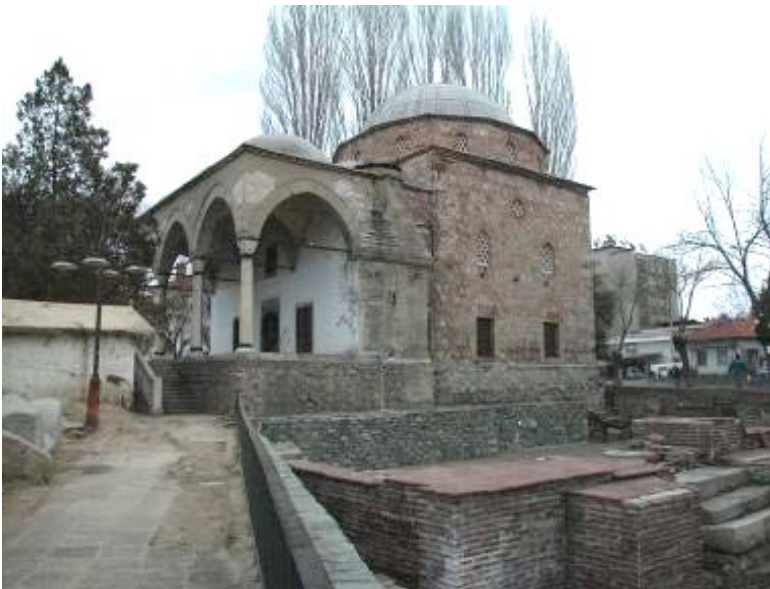
The condition is very good, although there are signs of moisture penetrating the half-dome.

**Oblique view from right side showing the setting of the monument above the site of the Roman baths of Kyustendil (Roman Pautalia). The present-day bathhouse, the core of which is Ottoman, is located little more than a dozen meters opposite the front of the portico, i.e. just to the left of the area contained in the photo.**

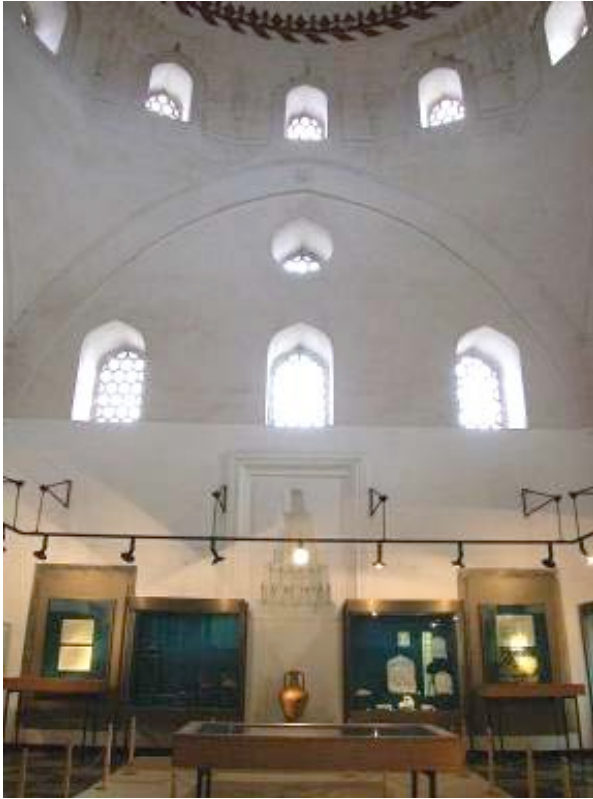
**View of *qibla* showing massive arches and pendentives that support the walls of the sanctuary. The soaring interior is well illuminated by windows penetrating three of the walls and the twelve facets of the drum of the dome.**

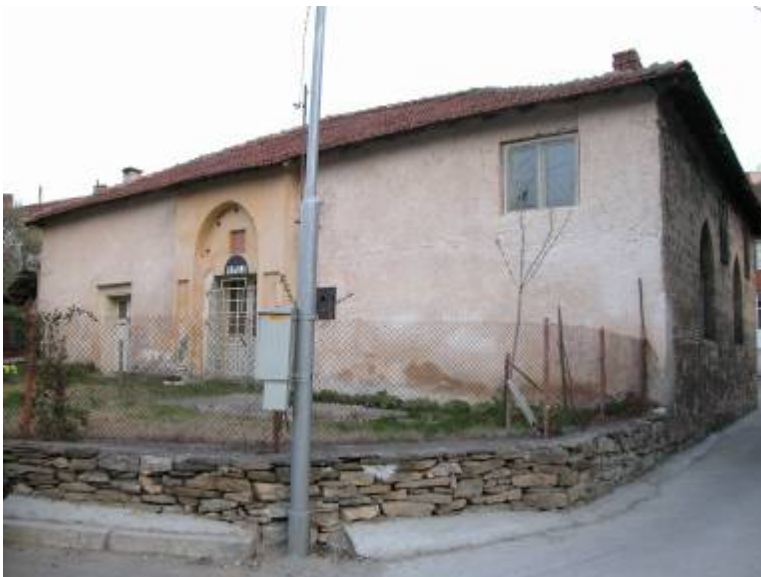
The building appears stable from the exterior.

**Oblique view of façade and entrance.**

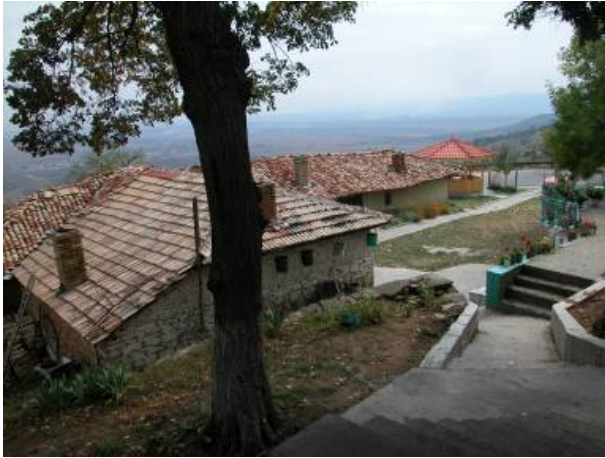
View southeast over the lower half of complex as seen from the porch of new building housing the grave of the saint and the meeting room for *cem*. On the left is the area for slaughtering animals for feasts and supplications. At the center is the rear of the structure containing lodgings. The new wooden *baldachin* is at center-right. Turgovishte is visible in the far distance.

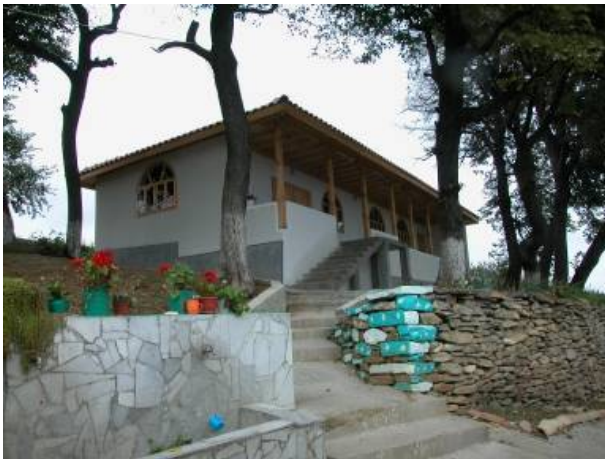
New structure. The room containing the grave is at the left, the meeting room for the *cem* is at the right. The style of the building is a modern take on traditional local styles.

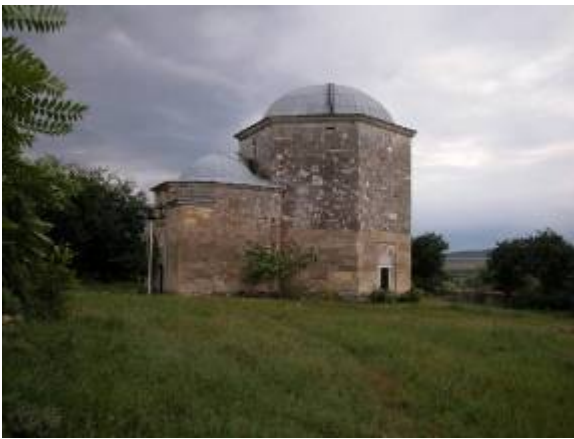
**Türbe of Ak Yazili Baba. Note enclosed portico with setbacks at left and right to form an irregularly-shaped hexagonal transition drum between dome and walls. Also note the tall heptagonal main chamber and its lack of transitional drum. Also interesting is the difference between the fine ashlar at the lower levels of the walls of the main chamber and the rougher stonework above.**

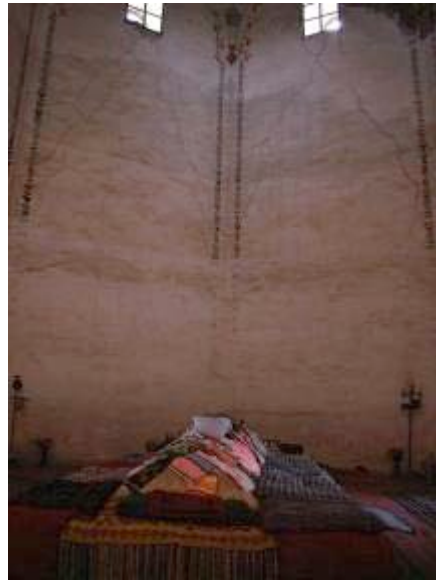
**Grave of the saint in the context of the walls of the mausoleum chamber. Note the height of walls and high placement of windows.**

The *meydan evi* (a hall for devotional ceremonies) is roofless and derelict, but the presence of an improvised stage and scattered chairs and lights indicates that it is also being used for performances. Recent restoration work was performed on the lead paneling of the mausoleum dome, but as interior dampness indicates, it was not successful. There are cracks in the interior walls that appear to have been unsuccessfully patched, as seepage is still evident. A sign at the site reports that the fencing that surrounds it to keep out grazing livestock was recently rebuilt by the Beautiful Bulgaria Project, a joint program of the UNDP and Bulgarian Ministry of Labor to provide work and training through the restoration of architecturally worthwhile façades. The site is a Bulgarian “Monument of Culture.” The owner is probably the Ministry of Culture via the regional museum in the nearby town of Kavarna (Asen Salkin, director).

2. Türbe Ak Yazılı Baba. This important monument requires urgent work to prevent ongoing water damage and exfoliation. The former *meydanevi* (meeting hall) at the site is also worthy of consideration.

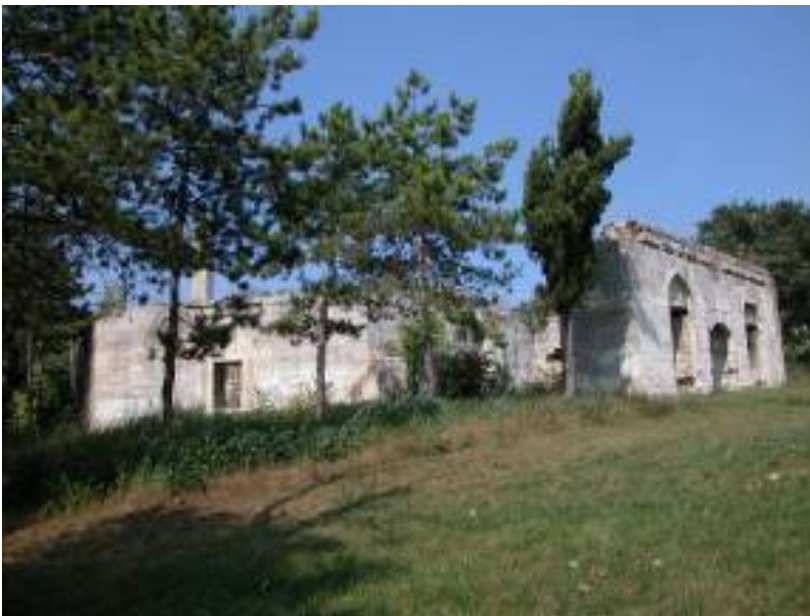
The condition of the mausoleum has deteriorated rapidly over the last decade. The exterior stonework shows extreme exfoliation and the interior dome and walls show signs of dampness and water damage. Intervention is needed to prevent this well-preserved monument from deteriorating rapidly. The ceremonial hall would benefit from being cleaned and conserved, and possibly by recreating its original (seven-faceted) conical wooden roof over the main hall and a similar roof over the vestibule.

**The *Meydan Evi*. Façade of the enclosed entrance gallery is visible at the far right; the remains of the seven-sided minaret-like chimney of the hearth of the main chamber is visible behind the tree at the left. Originally, the main chamber had been covered by a high conical wooden roof and the vestibule by a similar roof. These roofs were destroyed and the chimney of was damaged long ago, possibly (this requires verification) by a Russian artillery bombardment during the Russo-Turkish war of the 1870s. At the time, Russian and Bulgarian artillery indeed considered it sport to bombard minarets of mosques.**

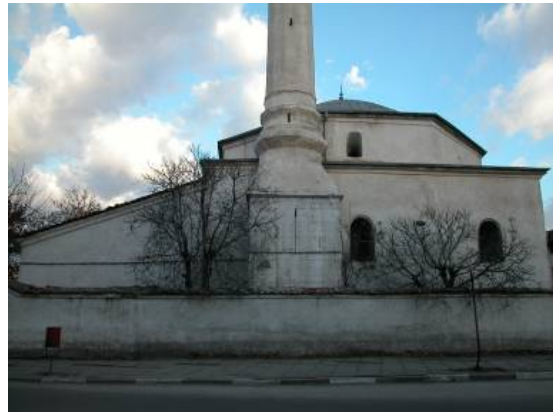
**Lateral view from street.**

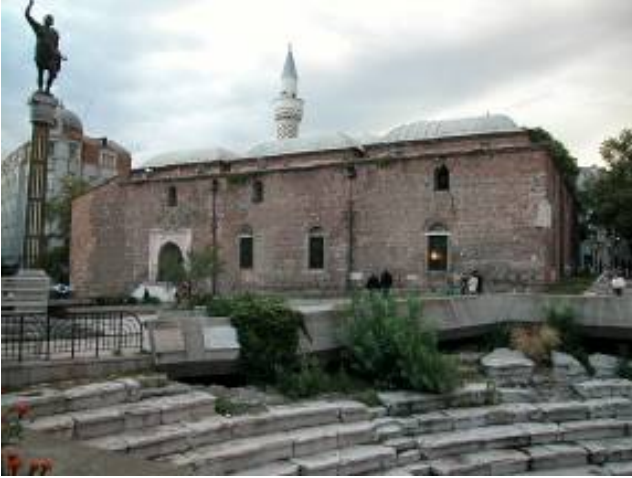
The building is superficially in good condition, but it faces some severe structural problems. Subsidence of the front right pier and right lateral wall has led to severely cracked arches and domes. Due to the sloping landscape, the mosque was built on an earthen works terrace and this increases its vulnerability. Cracks in the structural elements and domes of the mosque appeared during the 1928 earthquake at the city of Harmanli. The next threatening event took place in the 1970s, when Bulgarian archeologists uncovered and permanently exposed a Roman amphitheater adjacent to the mosque. This led to subsidence of the terrace and resultant instability of walls and piers at the right side of the mosque.

**This angle shows part of the excavated Roman amphitheater. Excavation exacerbated a subsidence problem that threatens the structural integrity of the mosque. The execution of the excavation during the 1970s may have been as much as a political statement to diminish the stature of a “Turkish” monument as it was scientific in its motivation.**

4. Muradiya (Cumaya) Camii, Plovdiv. This important early Ottoman monument set in the very center of Plovdiv suffers from cracks in its domes and walls that are of more than cosmetic significance. The structural integrity of the monument has been severely damaged by earthquakes and, worse, by the irresponsibly conceived and implemented excavations of adjacent Roman ruins.

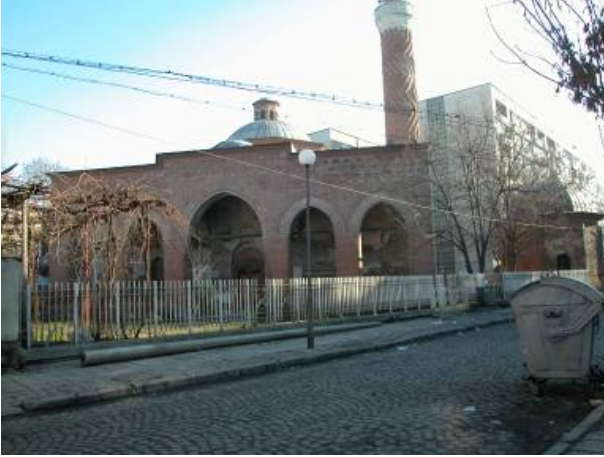
The mosque appears to be in quite sound condition, testimony to its builders and to the work of the late Nikola Mushanov, completed four decades ago.

**Façade from street. Note mass and severe geometry of the portico. Also note the covered oculus atop dome the dome of the central vestibule. The *türbe* of the founder is visible at the far right.**

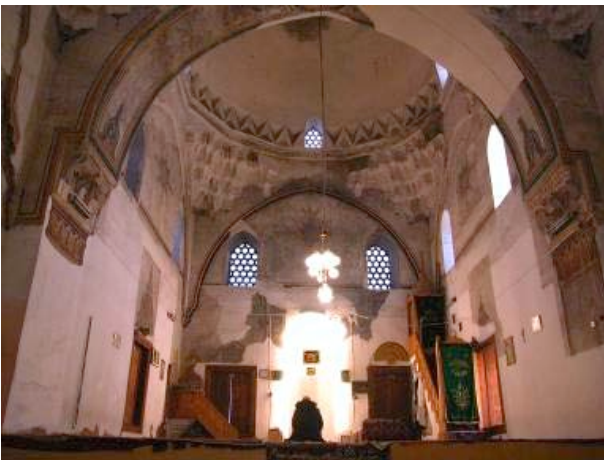
**Sanctuary as seen from central vestibule. Note the Turkish-triangle decorations along the drum under the dome and the large *muqarnas* (a type of corbel, which is a piece of stone jutting out of the wall to support any weight resting on top of it)-decorated pendentives.**

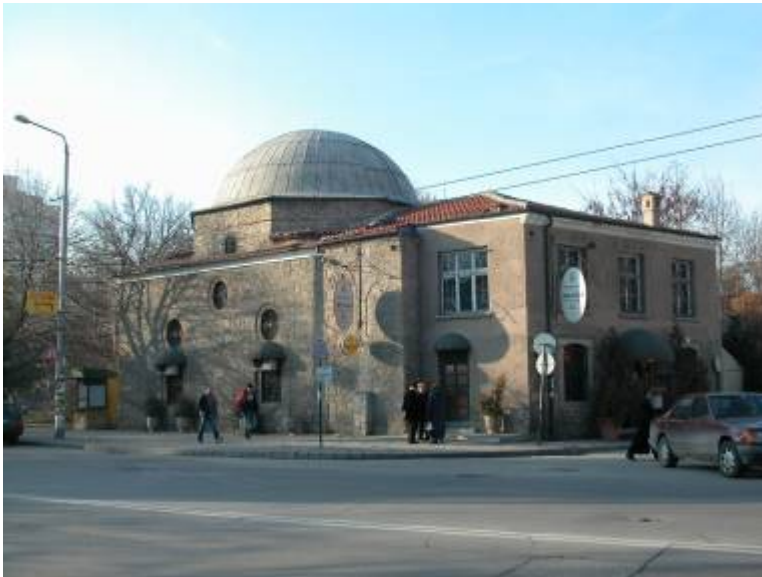
The former mosque is accessed through a nondescript early-20<sup>th</sup> century building. Its design consists of an Ottoman cube surmounted by a dome and an octagonal transitional drum. The simple but elegant structure was constructed of roughly hewn stone and some brick. Its diameter measures roughly 12 square meters.

**Oblique view showing adjacent building through which the former mosque is entered.**

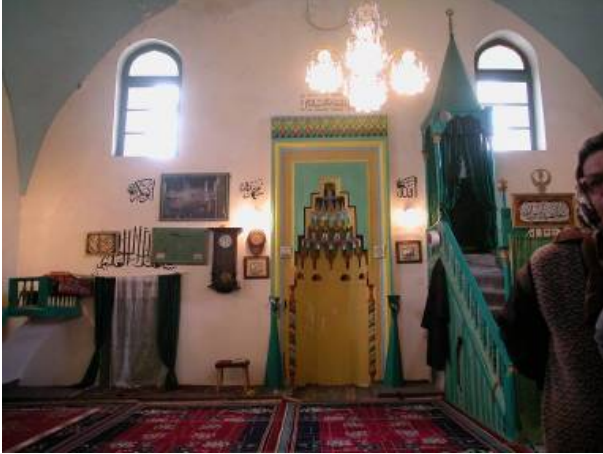
Interior, facing the *mihrab*.

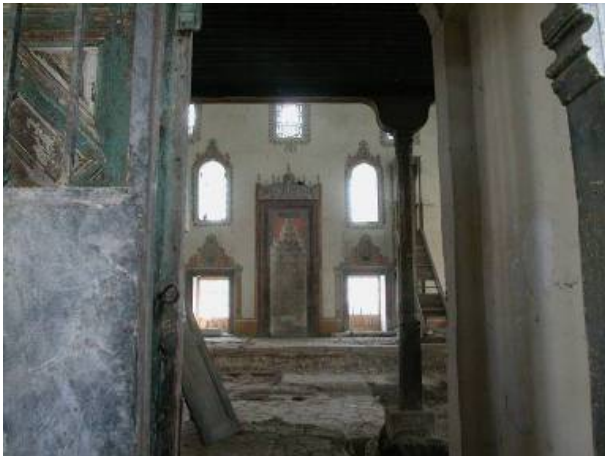
Interior as seen through a partially opened window lattice to the right of the entrance. Even this narrow angle of view tells us much about the mosque’s interior. At the far rear we see a stately *mihrab* and the light, open effect provided by the closely spaced and ornately decorated square and arched windows. Closer to the front is a narrow, graceful wood column supporting the *mafil* balcony.

The condition of the exterior appears quite good but for some signs of dampness and intermittent spacing between the ashlar (masonry) blocks. The exterior appears to require some conservation of the ashlar and some cosmetic work on the scars left on the façade from the inexpert removal of the original open portico. Reconstruction of a portico based on expert's conception of the original could be achieved. The floor of the mosque has been gutted and partially excavated. The interior needs substantial restoration.

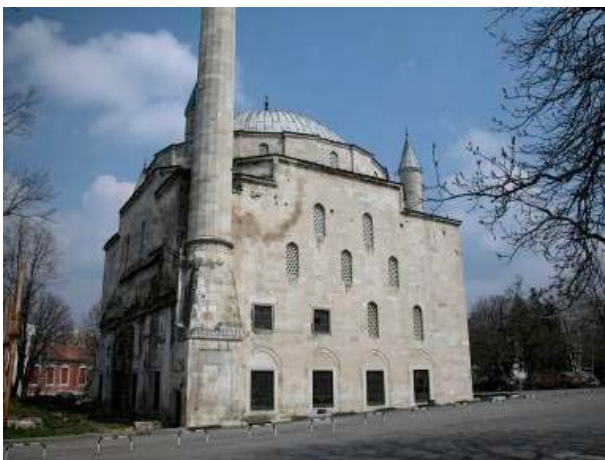
Façade and right lateral wall. The profusion of windows on wall and tambour provide light to the interior and turn the fortress-like walls of the mosque into filigree.

The monument's stonework is masterly and precise. The sheer, fortress-like lateral and rear walls are transformed into latticework by four stories of arched windows. The slender minaret of the mosque and the capped turrets mounted on its four corners give the building a soaring, upward-thrusting appearance that balances the severe geometry of its walls. The exterior of the sanctuary measures almost 20 by 20 meters and the interior measures about 16 by 16 meters.

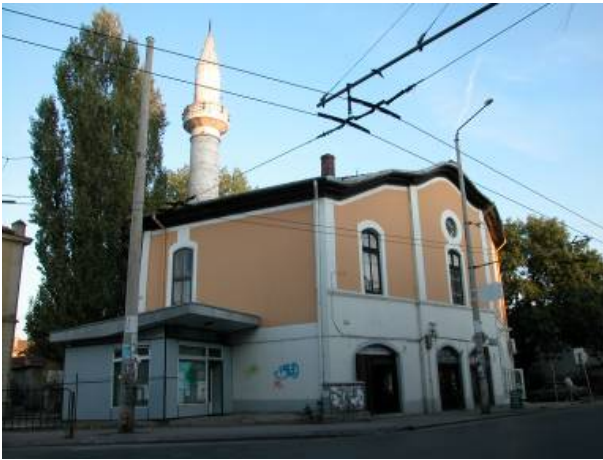
**Mosque is on the second story of the structure. Modern shops occupy the former carşi on the ground floor. Wall perpendicular to the façade encloses the portico which is entered through the rear of the structure.**

The mosque is situated on the corner of a main street and a side street. The entrance is through the large yard and playground at the left side of the structure when facing the *qibla* wall (the rear when viewing the structure from the boulevard). The *qibla* wall faces the side street. This unique two-story plan structure is complex. The building has a somewhat irregular external footprint due to its setting at the corner of a curved boulevard and straight side street.

The building is in good condition, but there is some evidence of dampness in the walls.

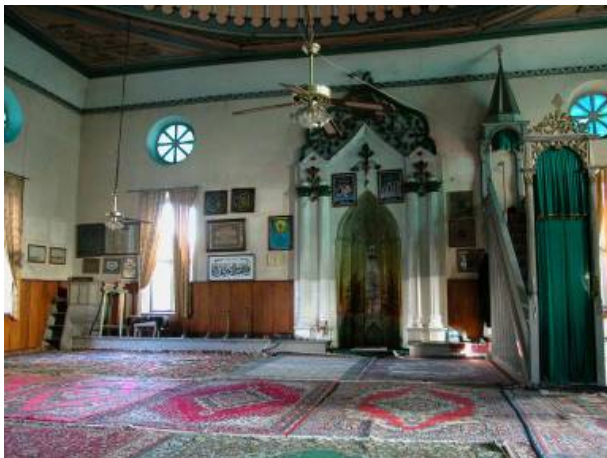
**Mihrab and minbar. Note eclectic, partially neo-gothic, decorative elements surrounding mihrab.**

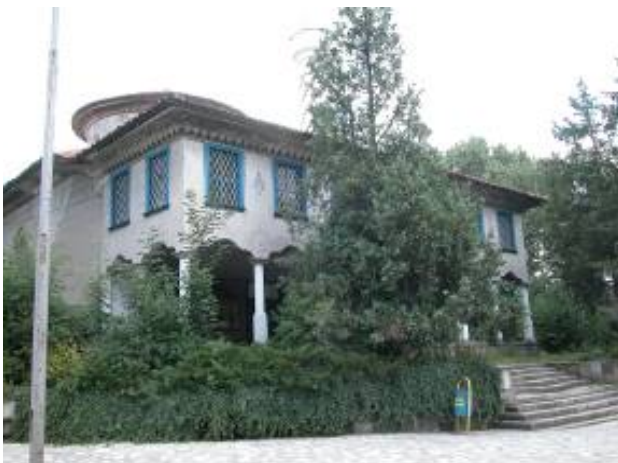
**Oblique view of front. Note second story over portico. This space housed the mosque's former *medresse*.**

The structure is comprised of a cube with four free-standing interior columns seemingly supporting the small interior dome. From the exterior, however, it is obvious that, unlike classical ottoman domed monuments, this mosque is actually a pitched-roofed cube surmounted by a small, centrally placed round drum that is covered with a circular-tiled roof. The interior dome, thus, is decorative rather than structural, thereby permitting the use of such slender columns and a transitional zone comprised of delicate, vestigial pendentives.

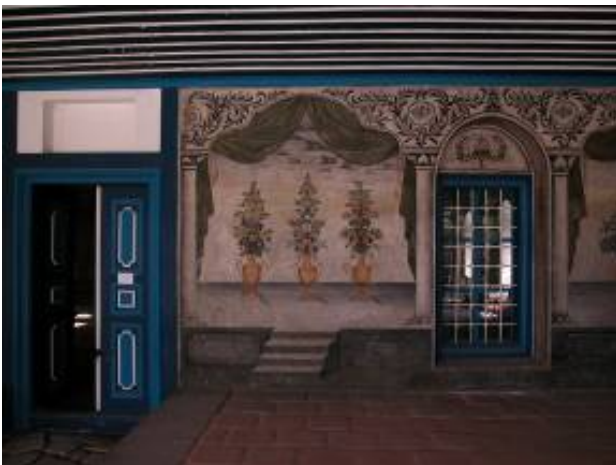
**Portico, painted decorations at entranceway.**

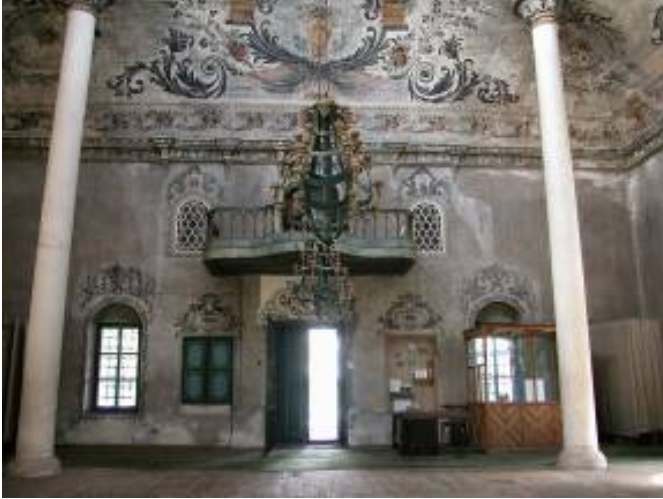
**Interior towards entranceway. Note small but elegant wooden *mafil* and laticework windows from *medrese*.**

The building was recently restored, but still shows obvious signs of dampness and leakage on the interior and exterior walls.

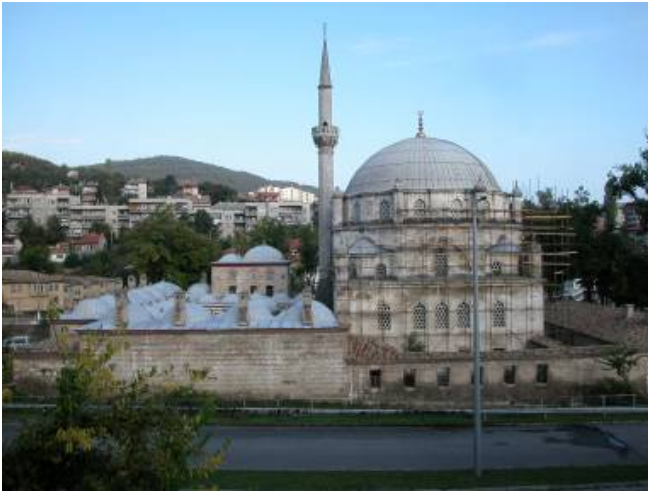
**The complete complex of the Mosque of Şerif Halil Paşa as seen from the rise on which Shumen’s Ottoman clock tower stands. On the right, the mosque itself, showing the *qibla* wall. On the left, the domes and chimneys of the *medresse*. At the left rear, the elevated twin-domed library of the mosque. On the left front corner, the original discretely-placed toilet facilities. The simple structure on the far-right housed a *mektep*. The road in the foreground is built on the filled-in bed of the Bokluca River, indicating the traditional river-side setting of the Külliye.**

The mosque comprises the core of a traditional Külliye (complex) also containing a *madrasah* (traditional Islamic school) library, and *mektep*. In accordance with tradition, the complex was sited next to a river, the Bokluca Brook, which served as the axis of the development of Shumla throughout the Ottoman period. The mosque and complex of Şerif Halil Paşa is the only remaining and fully intact Külliye in Bulgaria. The site is accessed from the street through a gate into a small courtyard preceding the mosque, and right into the courtyard of the *medresse*.

The Ottoman mosque is a typical dome-on-cube structure, with a galleried *medresse* arranged around a central courtyard containing a fountain. There is a library surmounting the peripheral wall. The complex was designed with a typical Kulliye layout. The interior and exterior of the Mosque are characteristic of the early stages of late-period Ottoman Baroque. The estimated measurements of the interior are 20 by 20 meters, and 25 meters high. The courtyard of the *medresse* is estimated to be 22 by 30 meters.

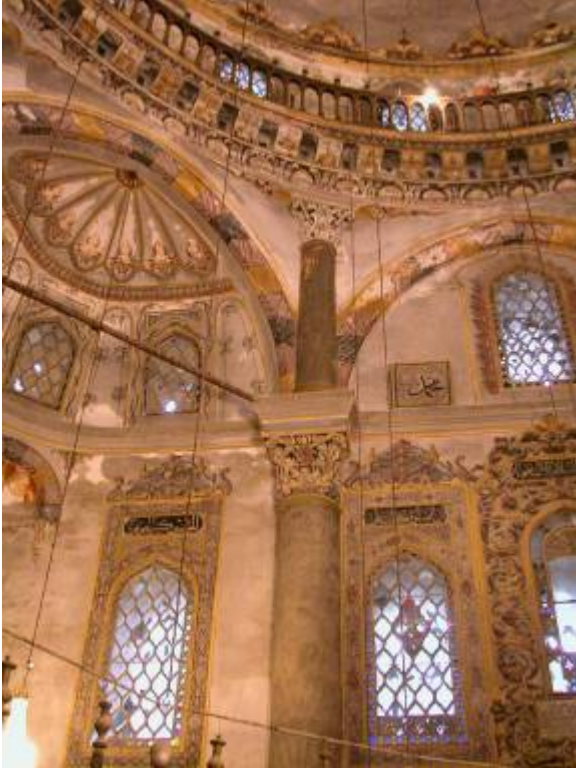
**Interior: Right lateral wall of mosque. Size and number of windows not only lights up the interior but also gives walls a gossamer, filigree-like appearance typical of the Ottoman Baroque. Note Baroque inspired decorations including non-Turkish capitals on columns and decorative placement of smaller columns upon larger even though actual structural support is provided by arches and pendentives.**

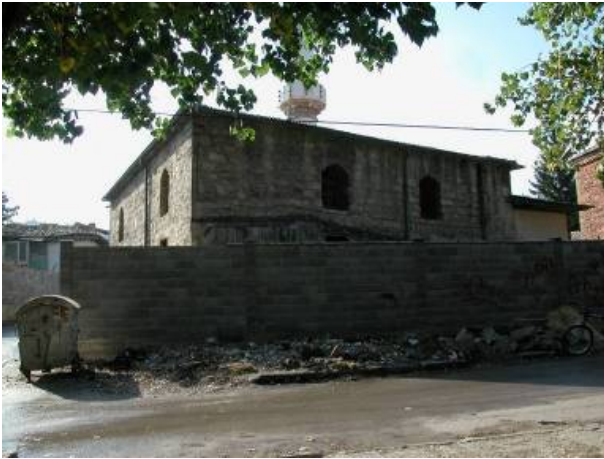
Lateral view from street. Note *qibla* wall at left and enclosed portico at right.

The mosque is a simple, stone, square structure preceded by a now-plastered and closed wooden portico. It has a flat ceiling and tiled roof typical of minor urban mosques during the Ottoman period. It is accessed from the street into a narrow walled courtyard. The interior of the mosque measures approximately 13 square meters; the portico is three meters deep, and the courtyard of the *medresses* is approximately 22 by 30 meters.

The building appears to be in fair condition despite some buckling of the walls and staining due to dampness.

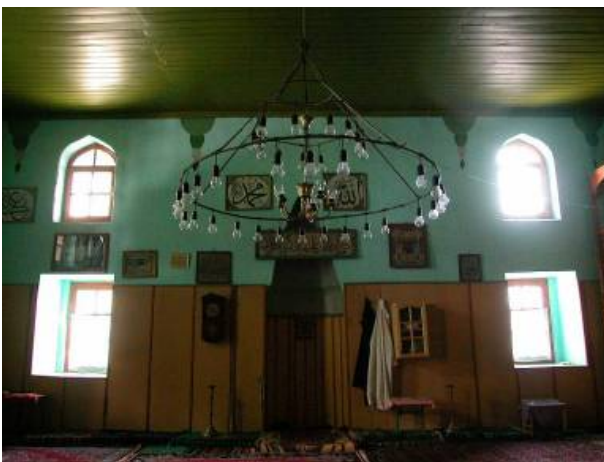
Interior towards *mihrab*.

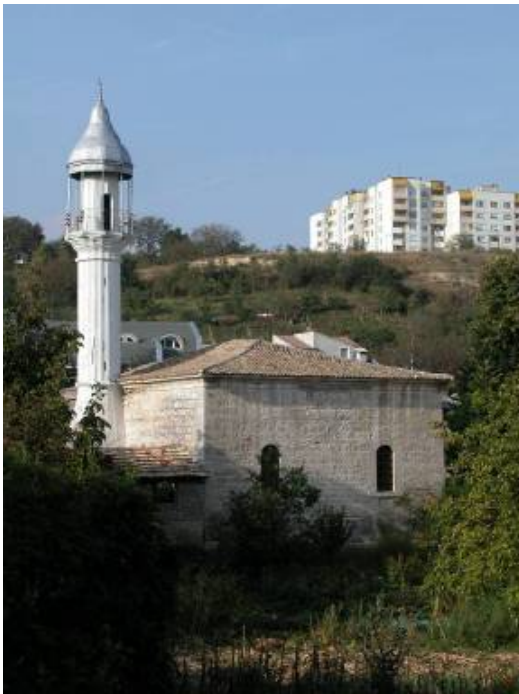
**Rear (*qibla*) wall of mosque. Note unusual 'bird cage'-like balcony of minaret.**

The site is accessed from the street and pathways that wind between houses in this village-like neighborhood. The stone building has a flat ceiling and a tiled roof typical of minor urban mosques during the Ottoman period. It was built with a rectangular floor plan with the main entrance on the long side. The estimated measurements of the interior are 13 by 10 meters. The portico is about three meters deep. The sheds built on to the ends of the portico make it wider than the mosque itself.

The building appears to be in sound condition.

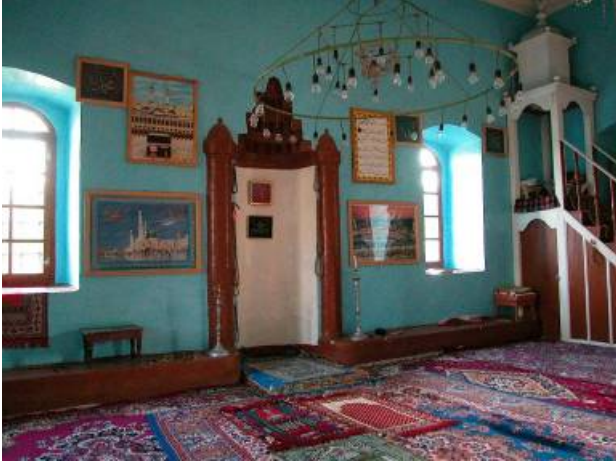
*Mihrab and minbar.*

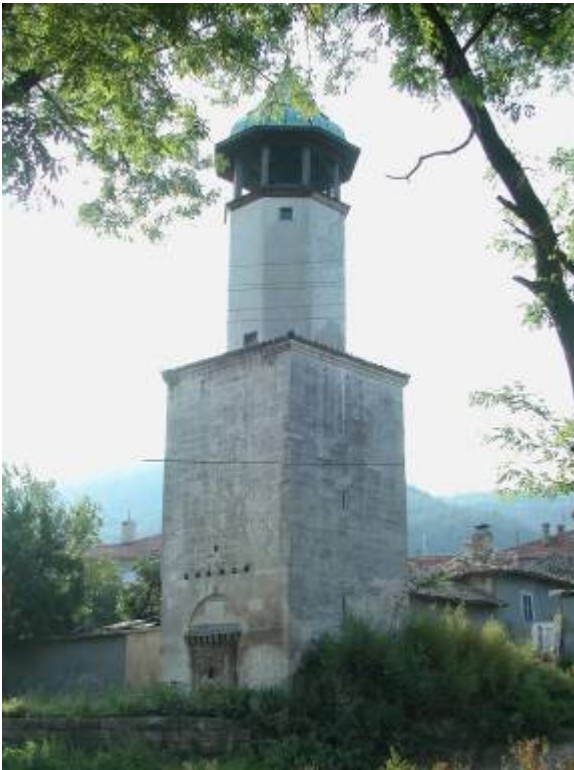
**The Clock Tower. The Clock Tower Mosque was located behind and to the right of the tower, just outside the frame of the photo. Note the fountain at the base of the tower. The six holes just above the fountain were sockets for wooden beams that had once supported a wooden eave that protruded out over the fountain.**

The clock tower consists of four elements: a rectangular ashlar base, an octagonal shaft of brick and/or wood, an open wooden lantern, and a metal conical dome. There is a fountain at the base of the tower with characteristic Ottoman baroque decorations. The mosque measured approximately 13 square meters. The base of the tower is approximately 4.5 square meters at ground level. The total height of the tower is about 18 meters.

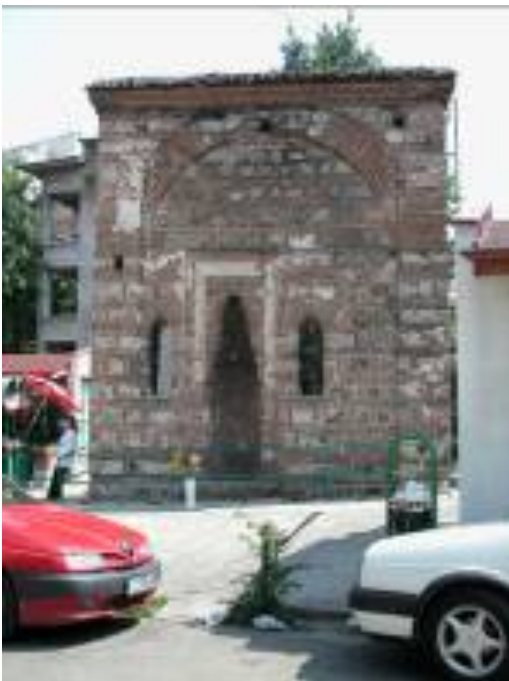
**Front of remaining wall. Originally, the wall was the rear, *qibla* wall of the structure. A *minbar*, probably of wood, would have stood at the right of the window next to the *mihrab*.**

The Old Wall is being well conserved.

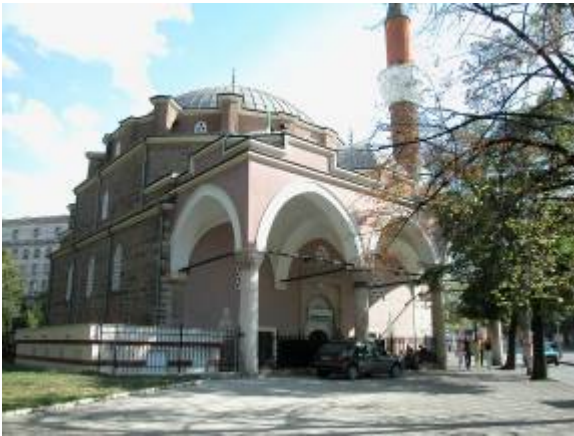
Façade.

This building is located at the center of contemporary Sofia - which is also the historical core of the city - next to the city's main source of mineral water and surviving late-nineteenth century bath house structure. It was originally built in 1570, restored during the 1970s and nicely renovated around 2000. This is the only functioning mosque remaining in Sofia, and it is in good condition.

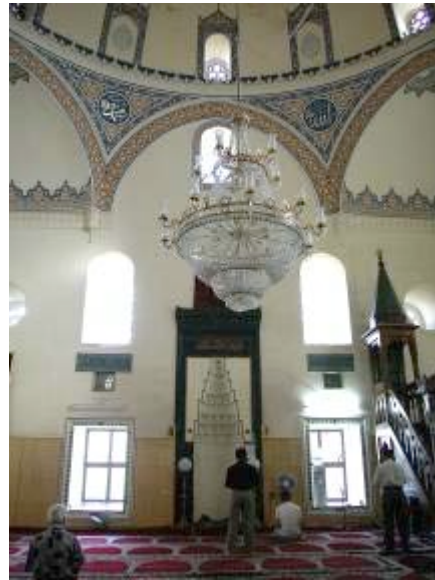
Interior facing *mihrab*.

The mosque is an example of the classic Ottoman dome on a cube with transitional drums. The interior transition from dome to cube is accomplished via four half-domes, each set at the intersections of the four walls; four arches, one at the center of each of the wall; and by a total of eight pendentives, each interspersed between half-dome and arches. The mosque is preceded by a three-domed portico and has two *mihrabs* imbedded in the façade for the prayers of late arrivals. A lateral portico has been bricked in, but still stands. Until a few years ago, it was used as the main entrance to the mosque and contained faucets for ritual washing before prayers. The interior and exterior show influences of the school of Mimar Sinan. The mosque is a fine example of a provincial application of classical Ottoman style and technique. The exterior of the cube measures roughly 20 or more square meters, and the interior roughly 19 meters.
