# **SELECTED MUSLIM HISTORIC MONUMENTS AND SITES IN BULGARIA**

**United States Commission for  
the Preservation of America's Heritage Abroad**

**2010**

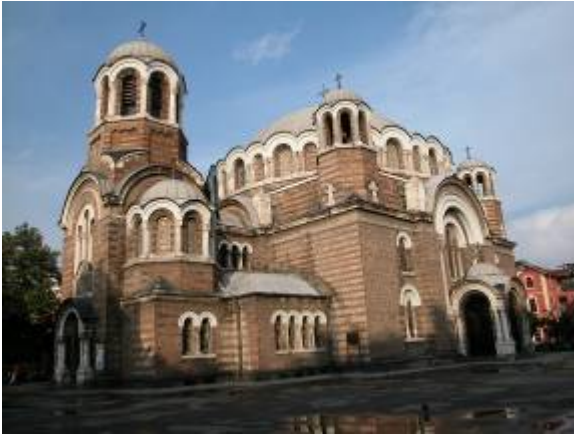
**Oblique view showing entranceway/bell tower and vestibule of church and original cube and dome of mosque. Towers and corners, cupolas and arches over lateral entrances, crinolined arches around dome, etc. obscure original clean lines of mosque.**

The church is in excellent condition.

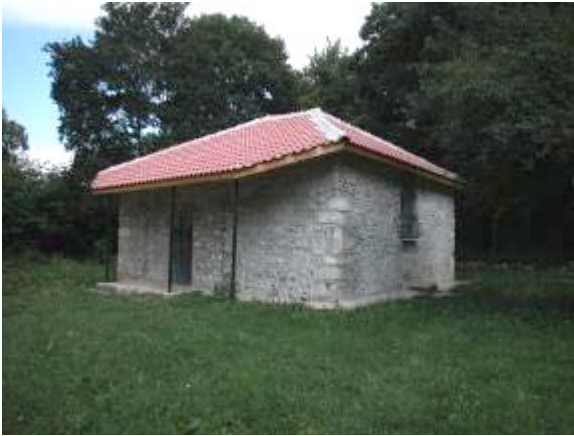
**Structure covering grave of Sofiavi Bali Effendi.**

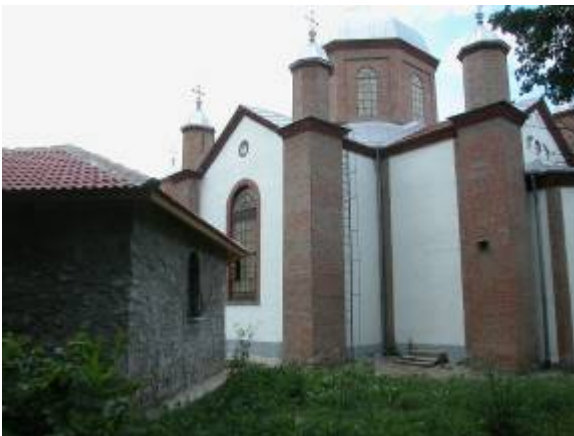
**Rear of structure showing position in yard behind the Orthodox Church of the Profit Elijah.**

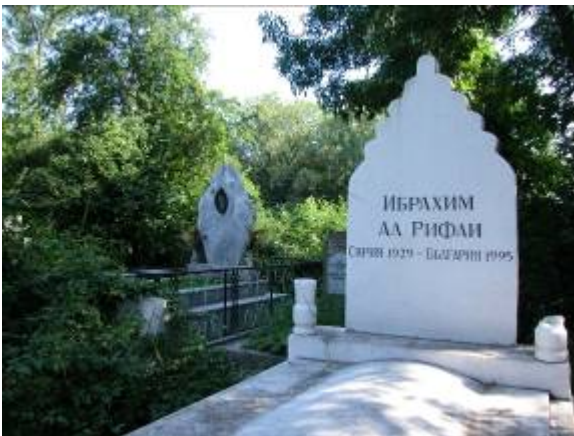
The site is somewhat overgrown.

**A grave of a Syrian Muslim reaffirms the official Muslim identity of the cemetery.**

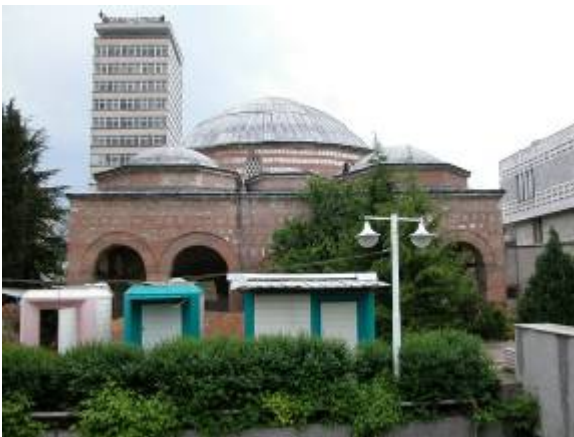
The round shape of the windows in the tambour, a form associated with the Ottoman baroque, suggests that the mosque may have undergone substantial renovation sometime late in the 18<sup>th</sup> century. A partial restoration was carried out in the 1970s, during which the portico was opened up (it had been bricked in after the independence of the Bulgaria and the flight of almost all of the city's Muslims). As part of the restoration, the mosque's minaret, (a late-19<sup>th</sup> century copy of its original minaret) was razed. The original minaret had been destroyed during the Russian bombardment and invasion of Stara Zagora in 1876. Adjacent buildings and a warren of alleyways were also cleared away at the time of the restoration, freeing the structure on all four sides. The site is owned by the Municipal Museum of Stara Zagora.

**Frontal view of mosque. It is possible that the three domes over the portico are the product of later (possibly 18<sup>th</sup> century) renovation. The six-pier, five-arch design of the portico ordinarily would suggest the presence of five domes, one over each arched space.**

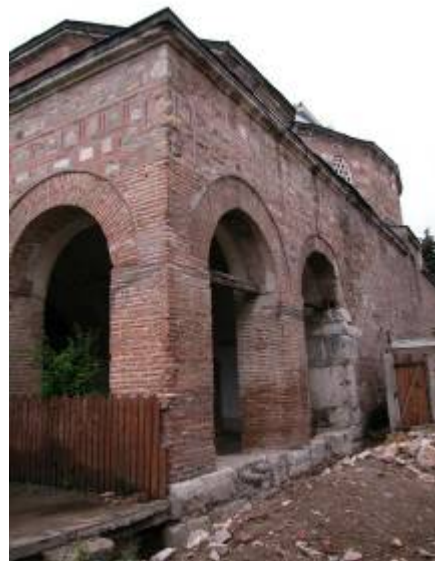
**Close-up of piers. Note that the piers are of brick. Also note the high-quality of the cloisonné work and that the portico and sanctuary are of a single piece. Signs of excavation work are visible in the foreground.**

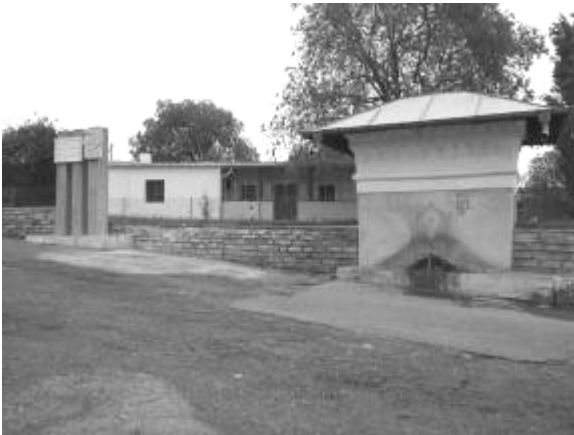
**The *tekke*. A monument from the Communist Party period can be seen on the far left.**

The former *tekke* now consists of a brick and stucco house-like structure serving as a *türbe* (and possibly meeting hall) and a fountain. The site is located in a classic *tekke* setting: a strategic high spot with a panoramic view and the presence of a traditional plane tree.

The site is in adequate condition. The *türbe*/meeting house appears well maintained.

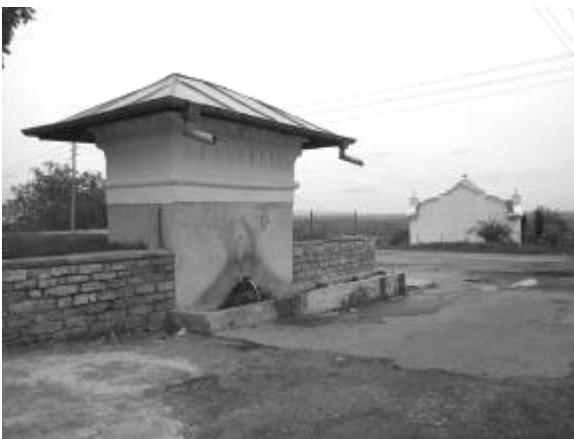
**Fountain in foreground. Heterodox sites are usually located at strategic sites with panoramic views. In the background: a view over the plane of Thrace. At the right, the back of the local Orthodox church, a measure of the traditional importance of the site.**

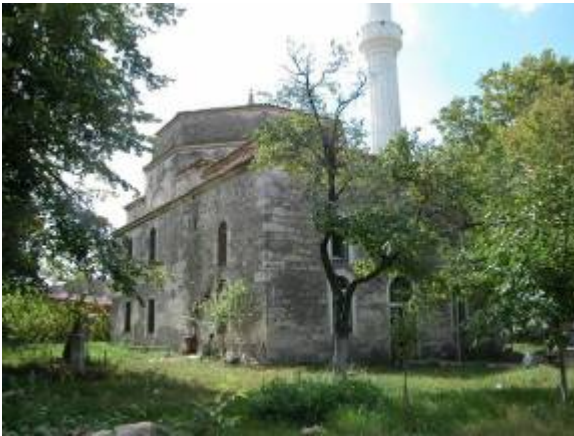
**Oblique view facing front of mosque.**

The mosque is located in a large enclosed courtyard with a locked gate on the main street of Suvorovo. The structure is a typical Ottoman domed cube preceded by an enclosed portico. The large sandstone blocks used to construct the building probably came from nearby quarries. The walls are unusually heavy, measuring approximately 1.2 meters in thickness. The transition from walls to dome is accomplished by eight arches and pendentives. Half domes in the corners of the interior lend support to the dome. The sanctuary measures approximately 12 by 12 meters. The enclosed portico runs the full width of the mosque and has a depth of about five meters.

The monument is in good overall condition.

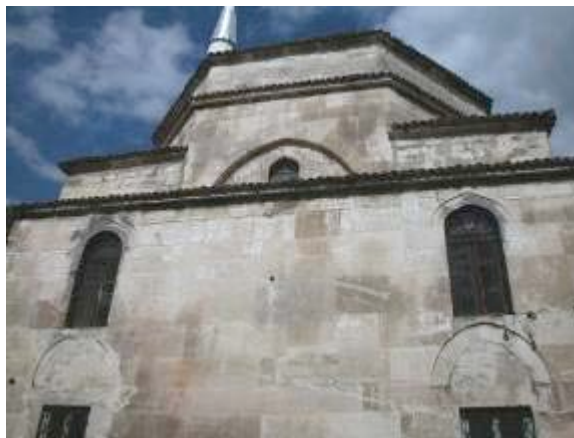
**Rear view also reveals quality of stone work and double tambour with corner "wings" covering interior half-domes.**

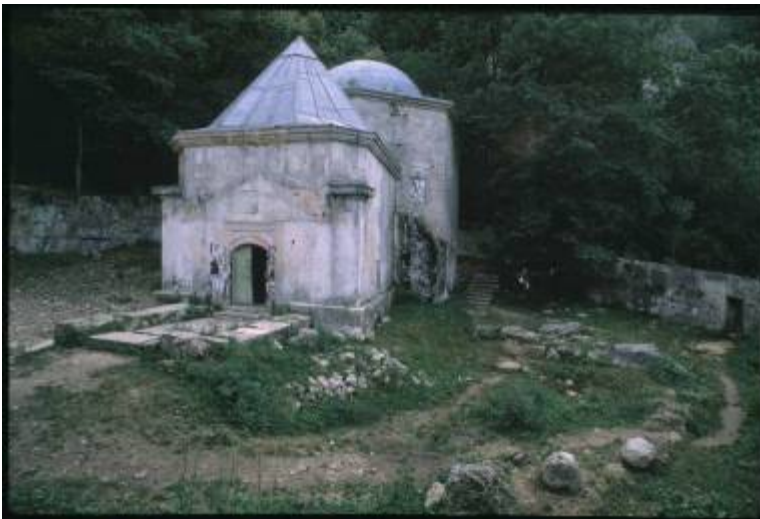
**Picture of the *türbe* taken during a visit to the site in July 1995.**

Prior to restoration, the dome over the main chamber of the *türbe* had been hemispherical and the dome over the vestibule a heptagonal "cone." The latter form, a seeming imitation of the conical domes of Seljuk mausoleums, which were numerous in eastern Anatolia, is an anomaly in Ottoman funerary architecture. Both of the domes were made of sheet metal applied over wood frames. They are most likely early 20<sup>th</sup> century replacements for domes destroyed by fire or leakage.

The complex was restored in 2004, financed by veteran Bulgarian politician Ahmed Doğan, head of the Movement for Rights and Freedoms political party (DPC), the primary constituency of which is the country's Muslim and ethnically Turkish populations. The primary focus of the project was the replacement of the domes and roofing and the repair of exfoliated stone.

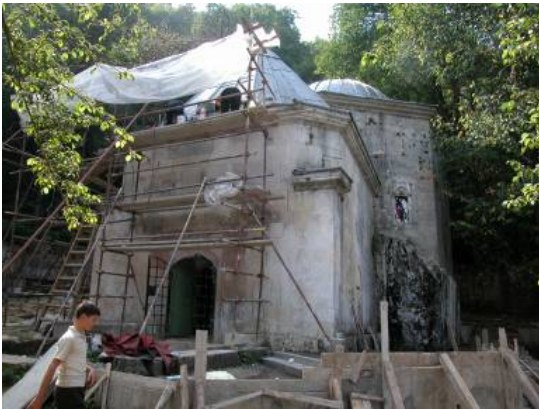
The structure was built in the Ottoman style with characteristics (including the style of transition from the dome to the walls of the main chamber) that suggest construction in the late 18<sup>th</sup> century. The heptagonal shape of the *tekke* is associated with Bektashi and Hurufi-related mausoleums; the number seven being significant in Hurufi teachings.

Oblique view of the *türbe* from right.

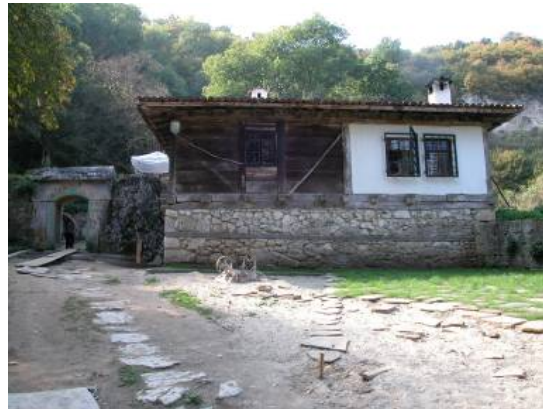
The nearby *imaret/mezdan* structure, a typical 18<sup>th</sup> century Turkish farmhouse, is two-storied and rectangular in shape. Including the porch, it measures approximately seven by five meters. The complex is set within an irregular heptagon enclosure.

Approach to complex. Gateway at left; rear of *imaret/mezdan* structure at right.

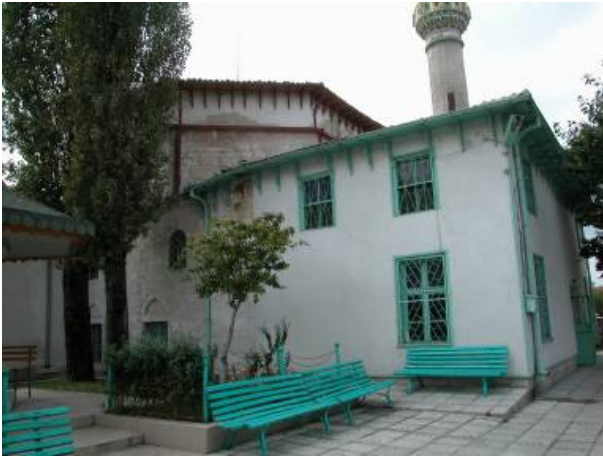
**Oblique view from within the courtyard of the mosque showing bricked-in portico, cut stone wall and straightforward octagonal drum housing the dome. A part of the modern eave of the *şadravan* is visible at the left.**

There is some evidence of dampness in the walls. There are crack lines in the dome, although it is unclear whether these are superficial or deep.

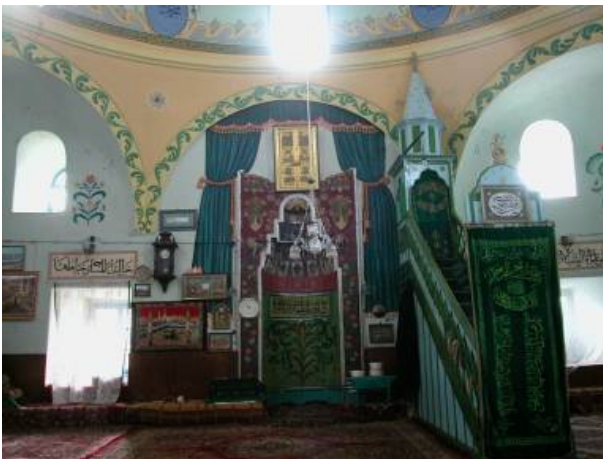
**Interior facing *mihrab*. Note low reaching squinches and pendentives and corner half domes.**

The solid, well-built, single-domed mosque is typical of later provincial Ottoman mosques in its stolid, somewhat squat appearance. In the interior, this is embodied in the oversized, low-reaching pendentives that cause the roof and dome to seem to press down on the observer. The almost square sanctuary is preceded by a portico. The exterior of the octagonal drum of the dome is simple and straightforward. Inside the mosque, the diameter of the dome spans almost the full length and width of the building. The dome rests on half domes, each set in the corners of the interior and on the resulting pendentives

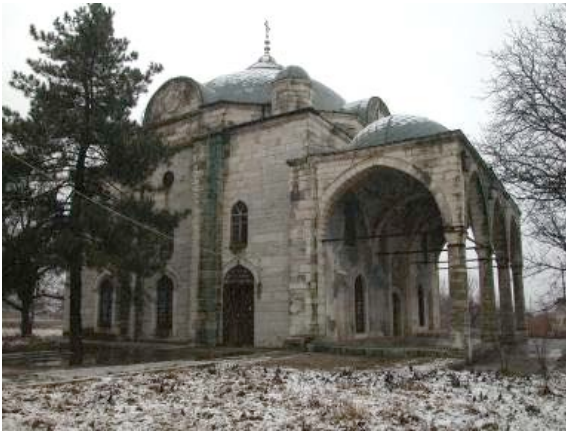
**Oblique view from side. Note the doorway cut into right-most of the three ground-level windows on the left of the building. Also note apparent vulnerability to seepage of buttressing piers on lateral wall.**

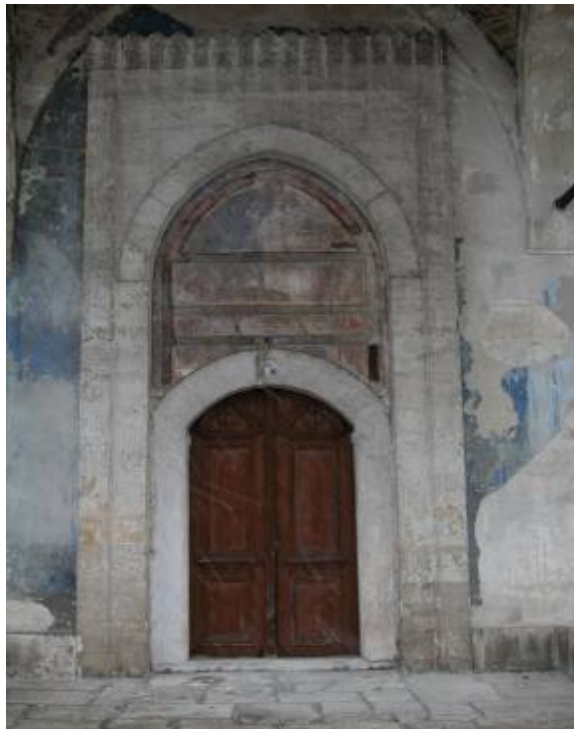
**Original entranceway.**

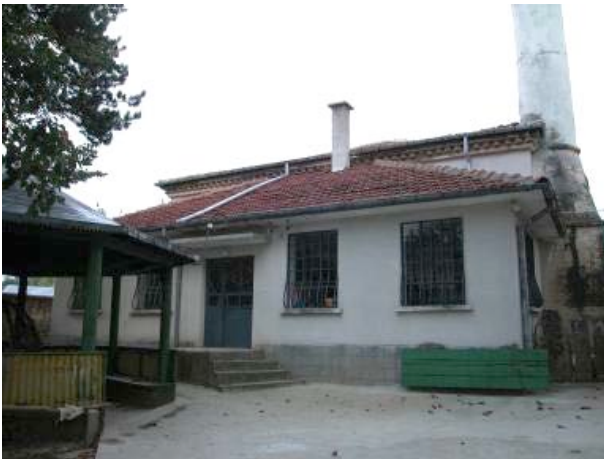
**Portico. *Şadravan* visible at left.**

The minaret dates to 1960s. The mosque and portico were repaired and repainted during the early 1970's, prior to the start of government orchestrated anti-Muslim persecutions in Bulgaria later in the decade. The portico, *şadravan* and garden appear well cared for. The exterior of the mosque shows evidence of attempted superficial repair as well as the presence of new gutters and run-off pipes, suggesting that there previously had been leakage into the interior that may have since been obviated.

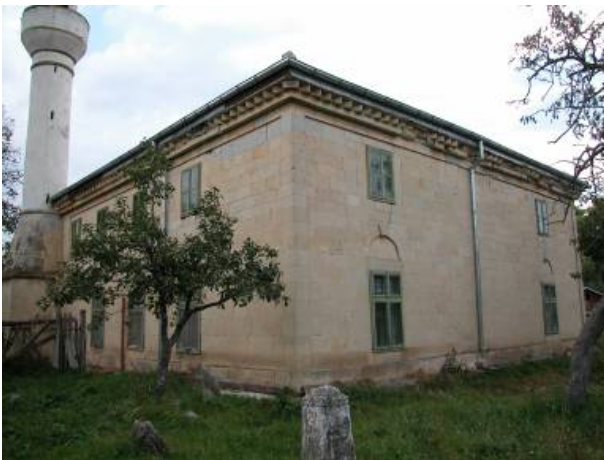
**Oblique view, right and *qibla* walls. Note placement of stones to create pediments and architraves in relief. Also note recently emplaced gutters and drain pipes.**
